# UNIQUE STABILISATION/ PROTECTION SYSTEM AND WATER ENERGISATION

# **CZECH WATER HEALING INVENTION**

# **APLICATIONS AND RESULTS**

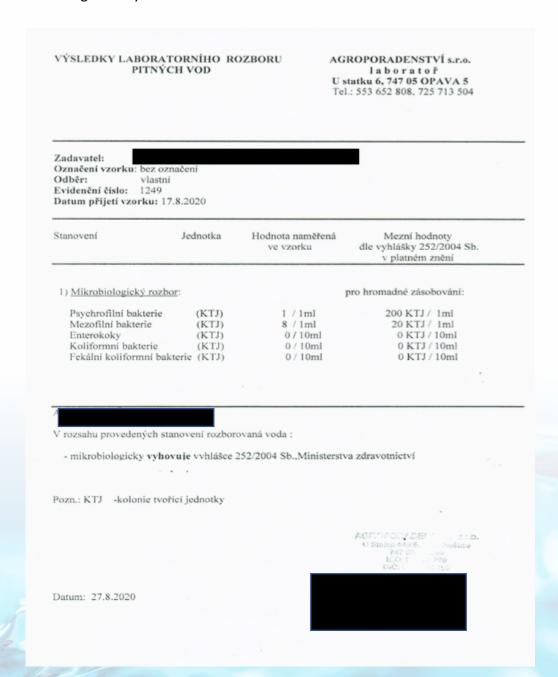
# b) 2<sup>nd</sup> analysis approximately 7 months after installation

In accordance with the agreement with the client, only a microbiological analysis for various types of bacteria was carried out. The collection was from the same collection point as in the previous case, i.e. the tap in the kitchen, which means after treatment with the STABFOR® unit. It is clear from the results that except for 2 indicators, the resulting values are 0 everywhere. By the further action of the treated water in the pipeline, all values will be gradually.

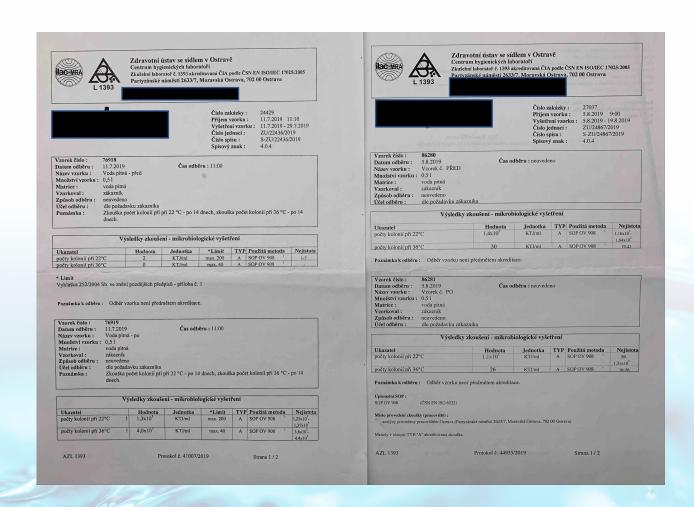
- The STABFOR® unit was installed in a residential unit in July 2019, and several measurements were performed.
- The first measurement, sample number 76918, was performed immediately after installing the STABFOR® unit. The KTJ reading was taken after 14 days of cultivation. The collection point was before entering the STABFOR® unit and a further collection from the kitchen tap. The results show a much higher number of KTJ when taken from the kitchen tap. The reason was the amount of biofilm deposited in the pipeline.

- The second sampling was performed approximately one month after the STABFOR® unit's installation. The KTJ reading was performed at the same interval as the first sample.

- Results show:
  - more than ten-fold reduction in the number of KTJ compared to the first sampling. These values show a gradual loss of biofilm in the pipeline.

- reduction in the number of KTJ in the water treated by the STABFOR® unit compared to the inlet water

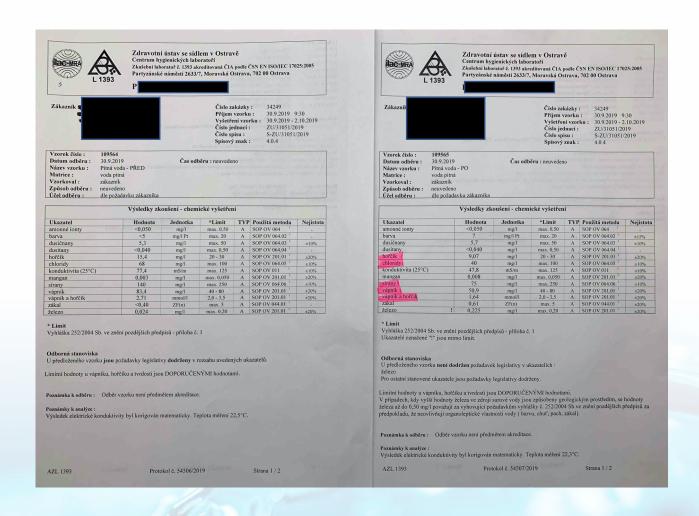
#### Chemical analysis\*

A chemical analysis was performed approximately 2 months after installing the STABFOR® unit in the household. The collection point was before entering the STABFOR® unit and a further collection from the kitchen tap.

Results show a decrease in values:

- magnesium by 41%
- chlorides by 41%
- sulphates by 46%
- calcium by 39%
- calcium and magnesium by 39%

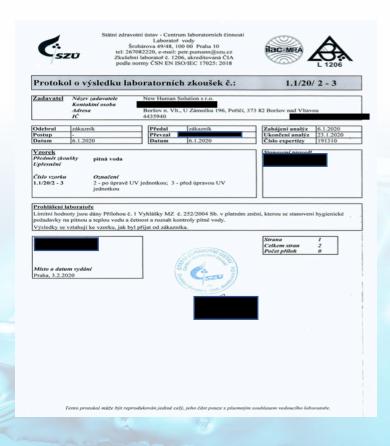
# Column 1.1/20/2 = after treatment. Column 1.1/20/3 = before treatment

The STABFOR® unit was installed in December 2019 in a family house on the water supply to the building (after the water meter). Microbial and chemical analyses were performed one month after installation. Samples were taken from the collection tap before entering the STABFOR® unit, i.e. after the water meter (Column 1.1 / 20/3) and then from the kitchen tap (Column 1.1 / 20/2 = after treatment)

- A reduction in the number of KTJ when reading after 3 days to 0
- A reduction in the number of KTJ when reading after 7 days by 94%
- A reduction in the number of KTJ when reading after 14 days by an average of 50%

The chemical analysis shows changes within the deviation. The increased content of calcium and magnesium was due to gradually cleaning the upper biologically active growth layer inside the pipe (scale).

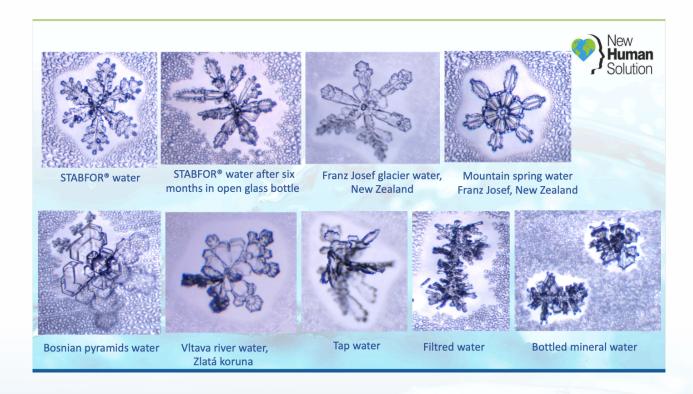
In the spring of 2020, we studied water energy from various sources using crystals. The water was frozen and then examined under a microscope and photographed with its crystals.

Even after 6 months, water from the STABFOR® unit retains its energy in an open glass bottle and is significantly better in energy than the other studied water.

We also investigated the energy effect of BIONANOSTOP® on rainwater. According to photos of the crystals, it is clear that BIONANOSTOP® (powder) can energise rainwater.

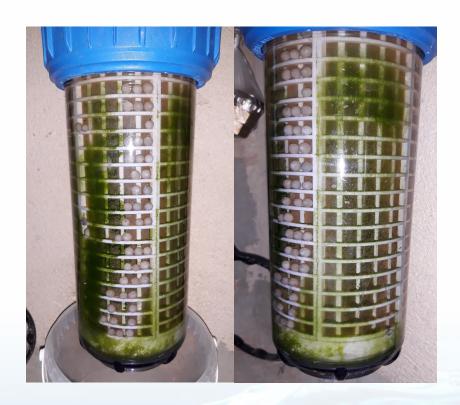
We inserted BIONANOSTOP® BA stabilisers into the water filter, which are one of the technologies used in the STABFOR® unit. According to the photos below, the filter is covered with microbial vegetation. In the area where the stabilisers and the surroundings are inserted, microbial growth is cleaned from the filter.

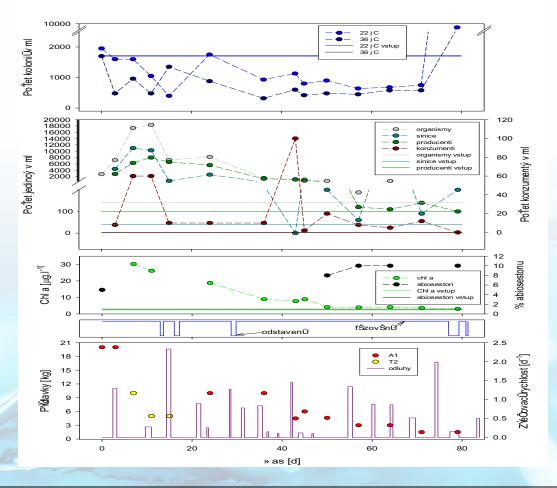
Report from the Czech Republic Academy of Sciences Institute of Botany from the application of nanoparticles to the power plant external cooling circuit:

BIONANOSTOP® in laboratory micro-testers (Miniaturised algal test according to Lukavský et al. 1995) affects a wide spectrum of autotrophic microorganisms, i.e., cyanobacteria and algae. According to the protocols of the Institute of Public Health, there has indeed been a decrease in bioseston — algae in technological tanks, which is related to the decrease in chlorophyll  $\alpha$ .

The application of BIONANOSTOP® is functional because it minimised and maintained the biological recovery of the algae- and cyanobacteria-monitored circuits, and we recommend continuing the application and testing as outlined in the scheme.
